TS-AMD- 82048b
December 1982

AERIAL PHOTOGRAPHIC ANALYSIS OF HAZARDOUS WASTE STUDY SITES New Mexico and Texas

Region VI

E. V. Dabney
Environmental Programs
Lockheed Engineering and Management Services Company. Inc.
Las Vegas, Nevada 89114

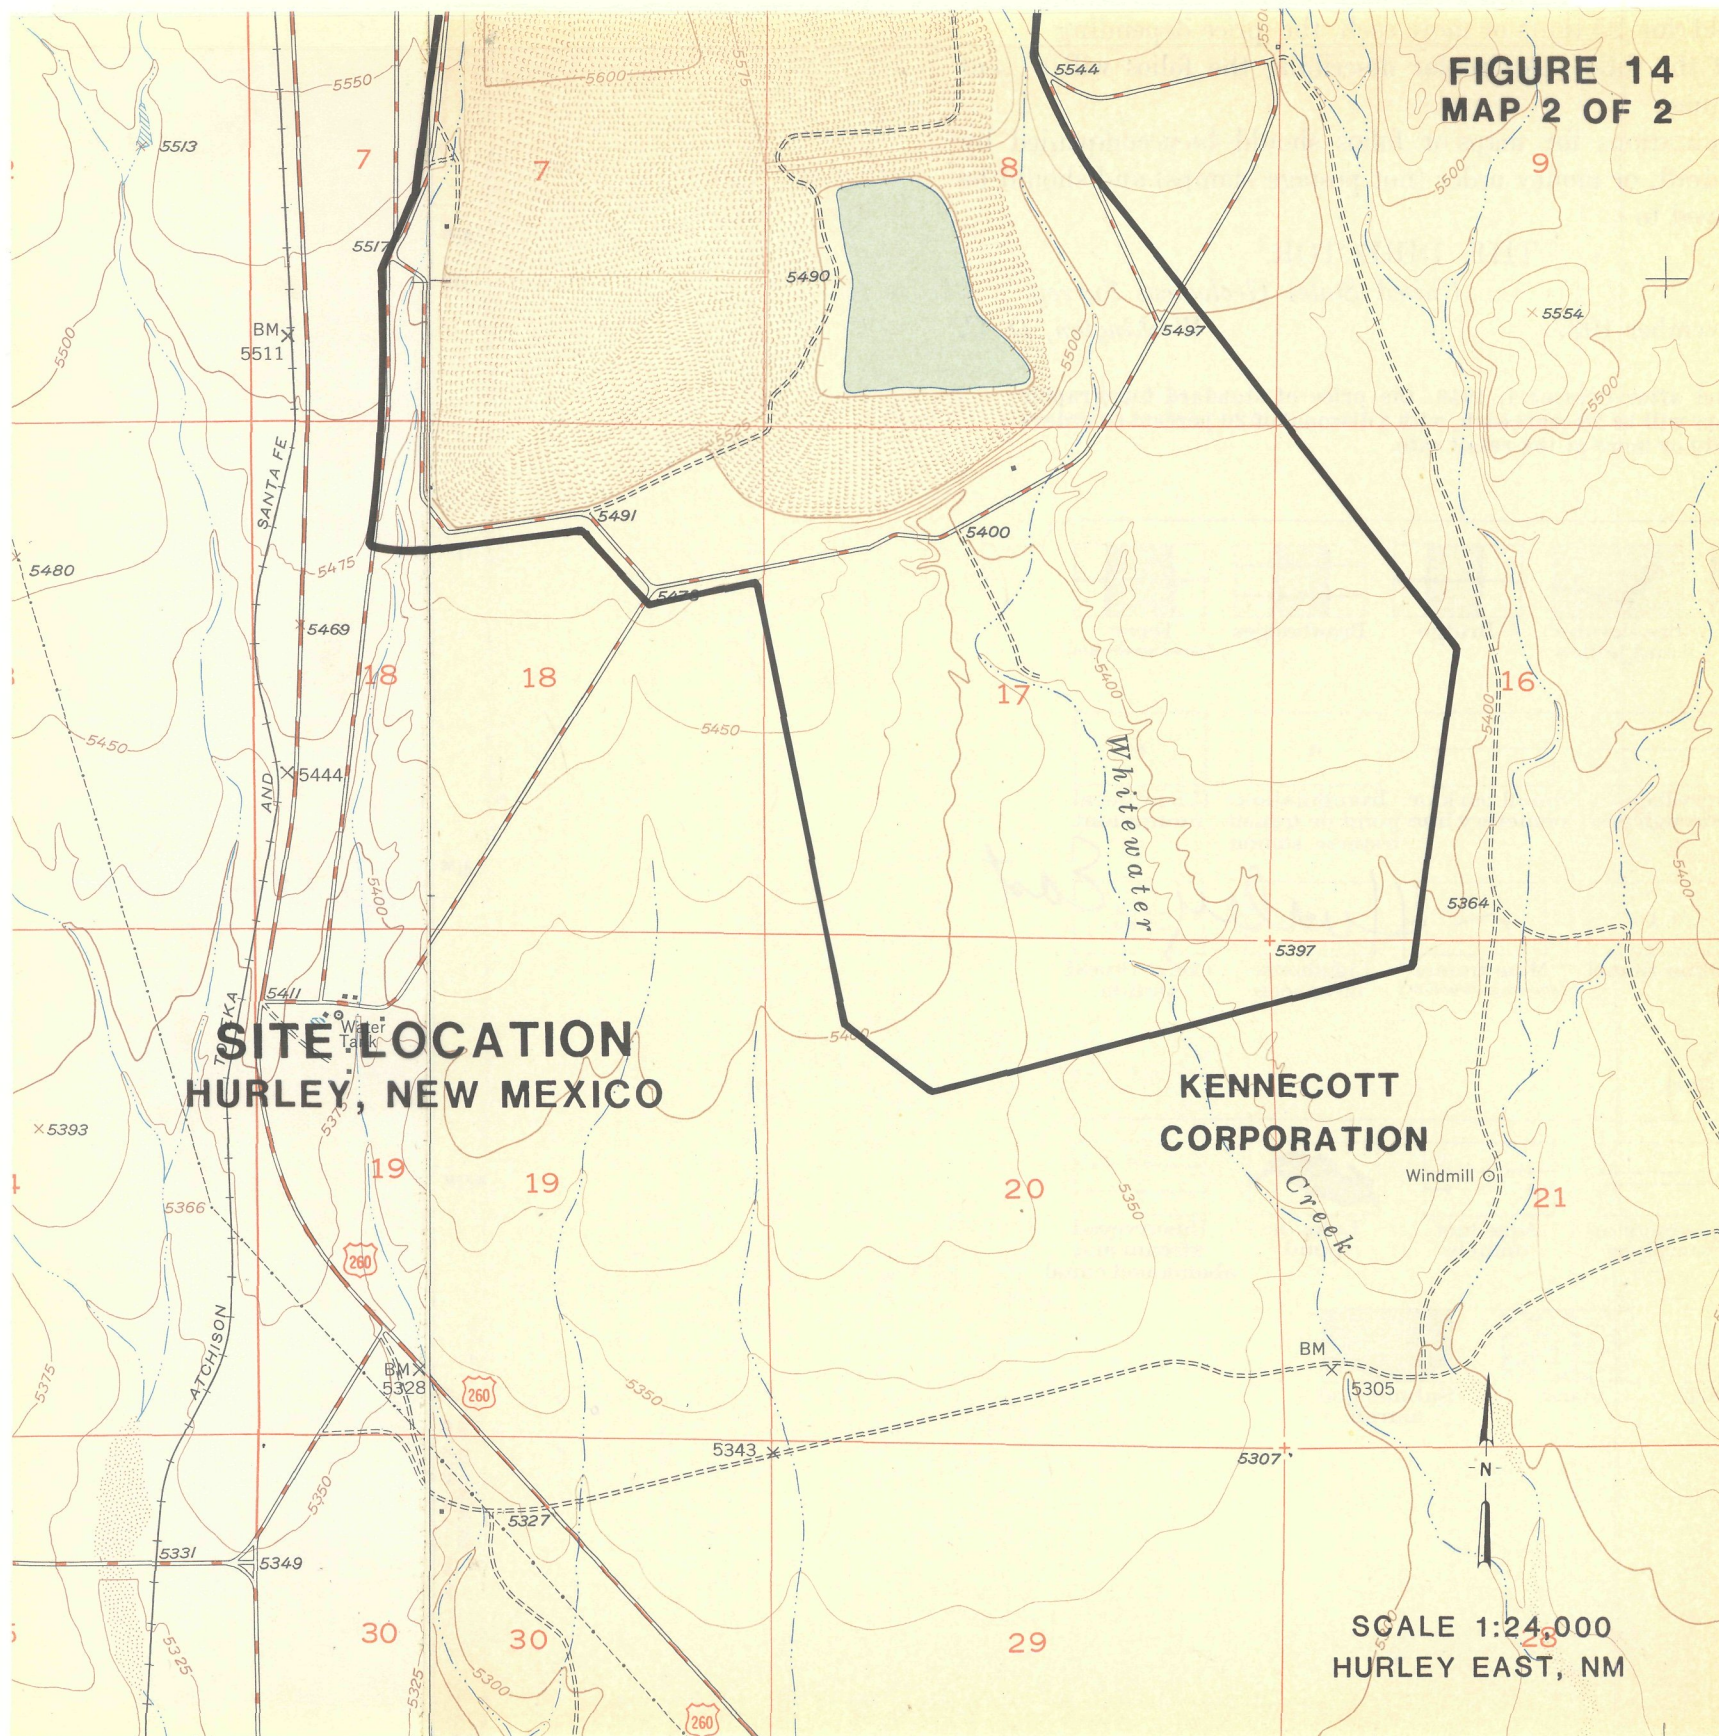
PHOTO 1 OF 14

← — — DRAINAGE

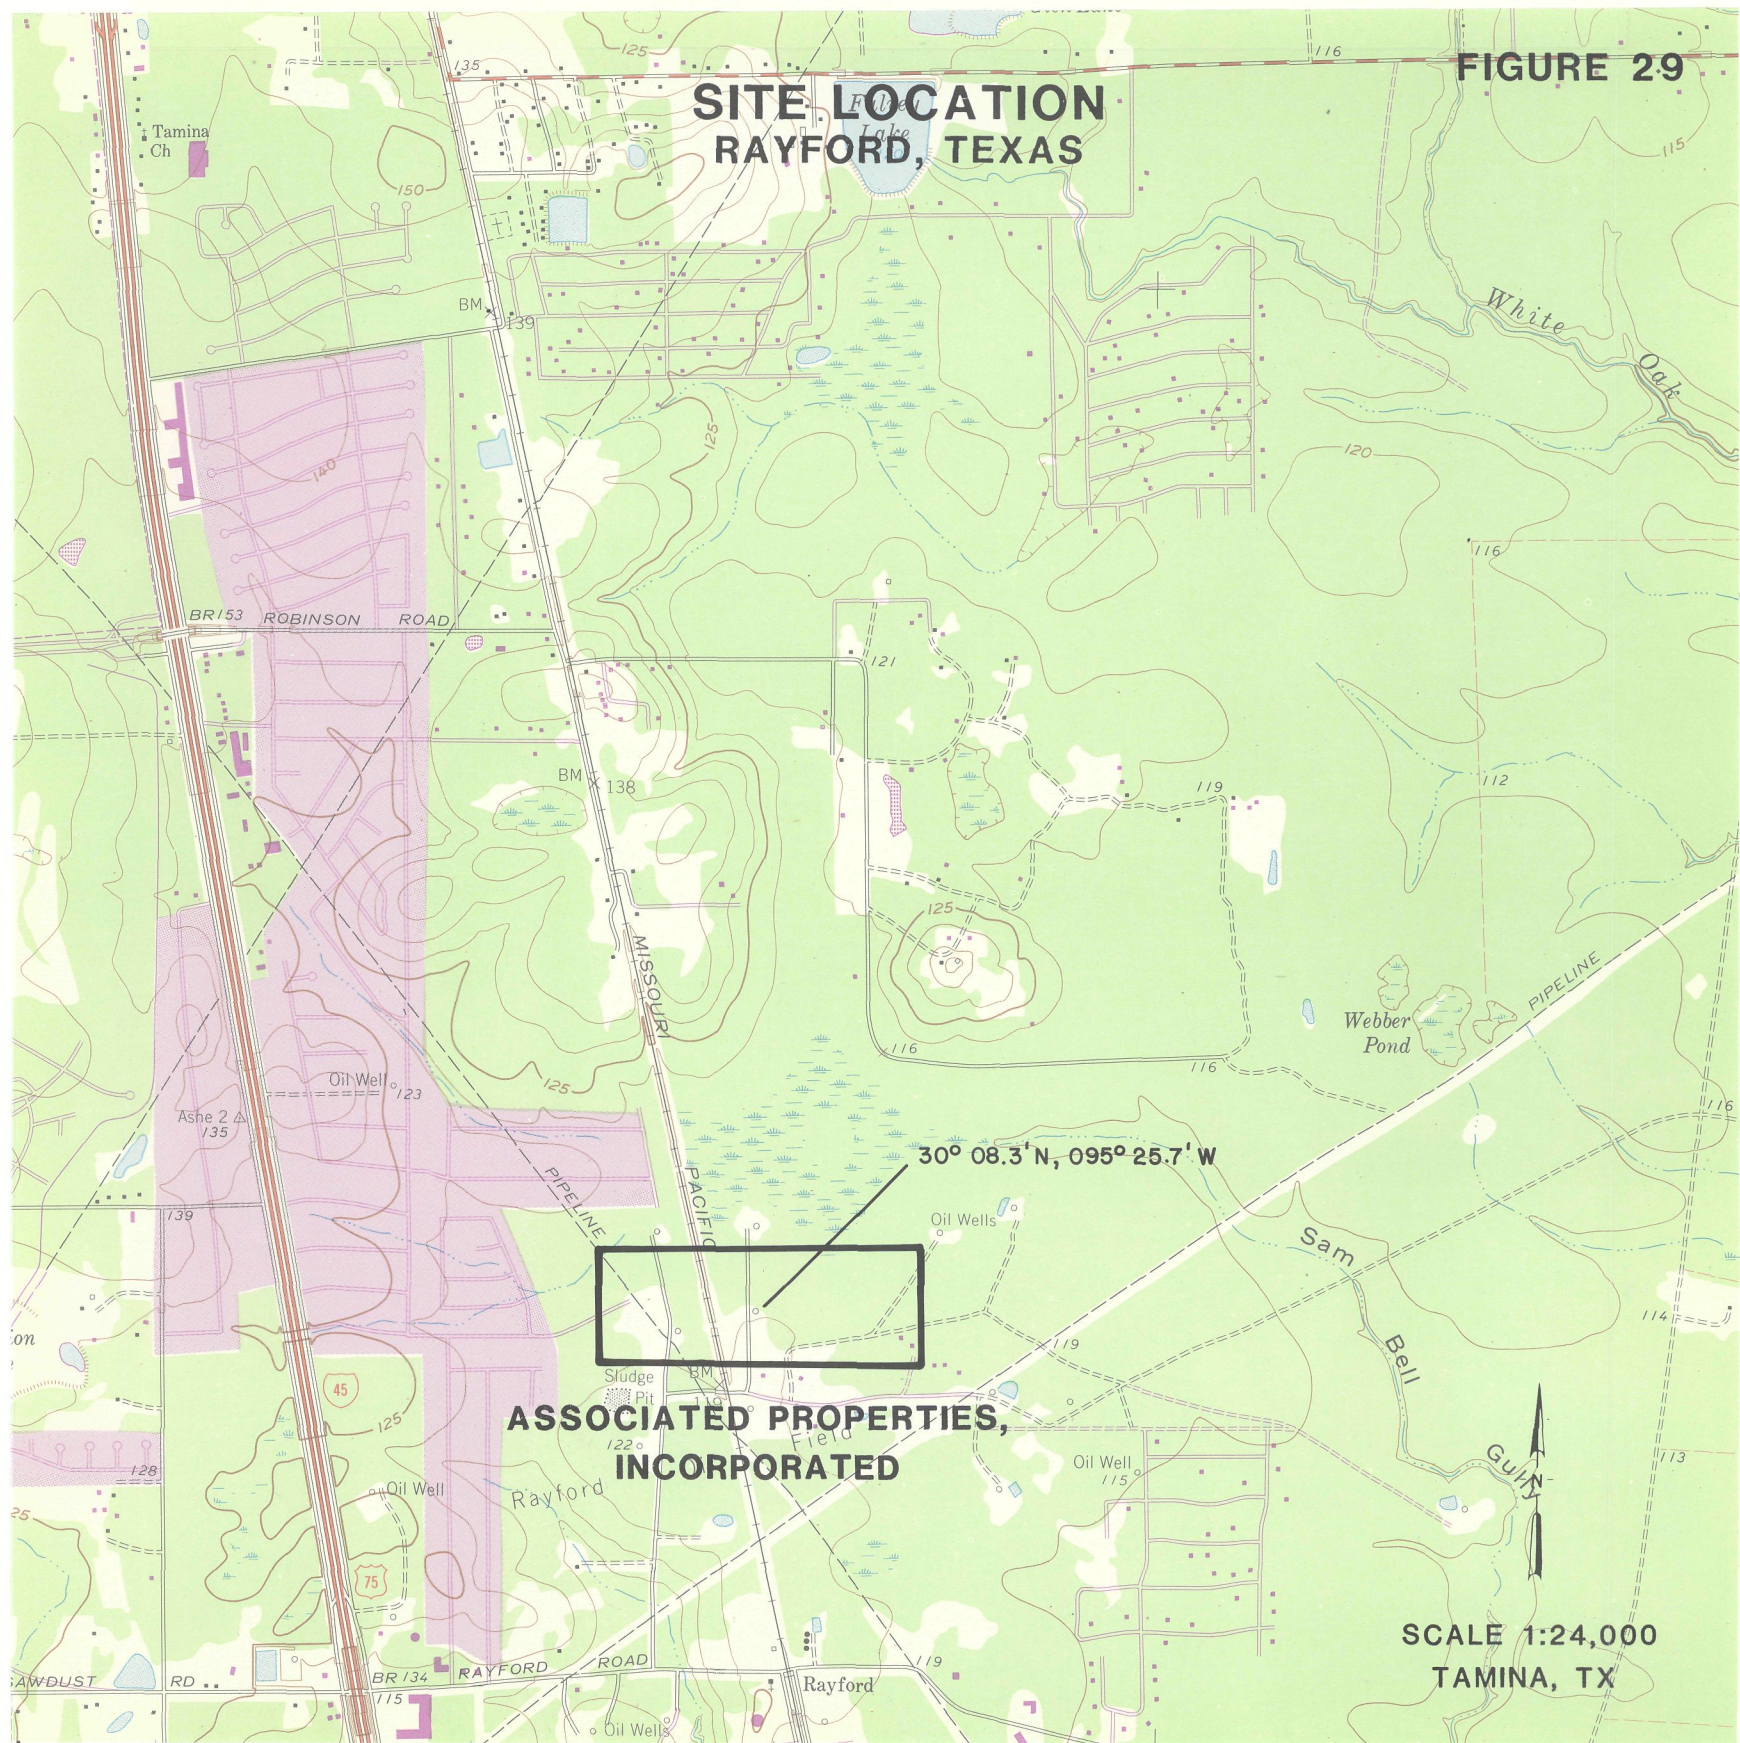
No drums are apparent on the 1982 photograph, however, deposits of tar and a milky gray substance were noted. Stains are also present upon a berm wall, but no connection can be made between these stains and an adjacent spoil area. There is

no evidence of sheen or contaminants within the ditch although there are sufficient drainage outlets to the ditch to allow contamination to occur. Vegetation damage is visible at the disposal site and in areas to the south.

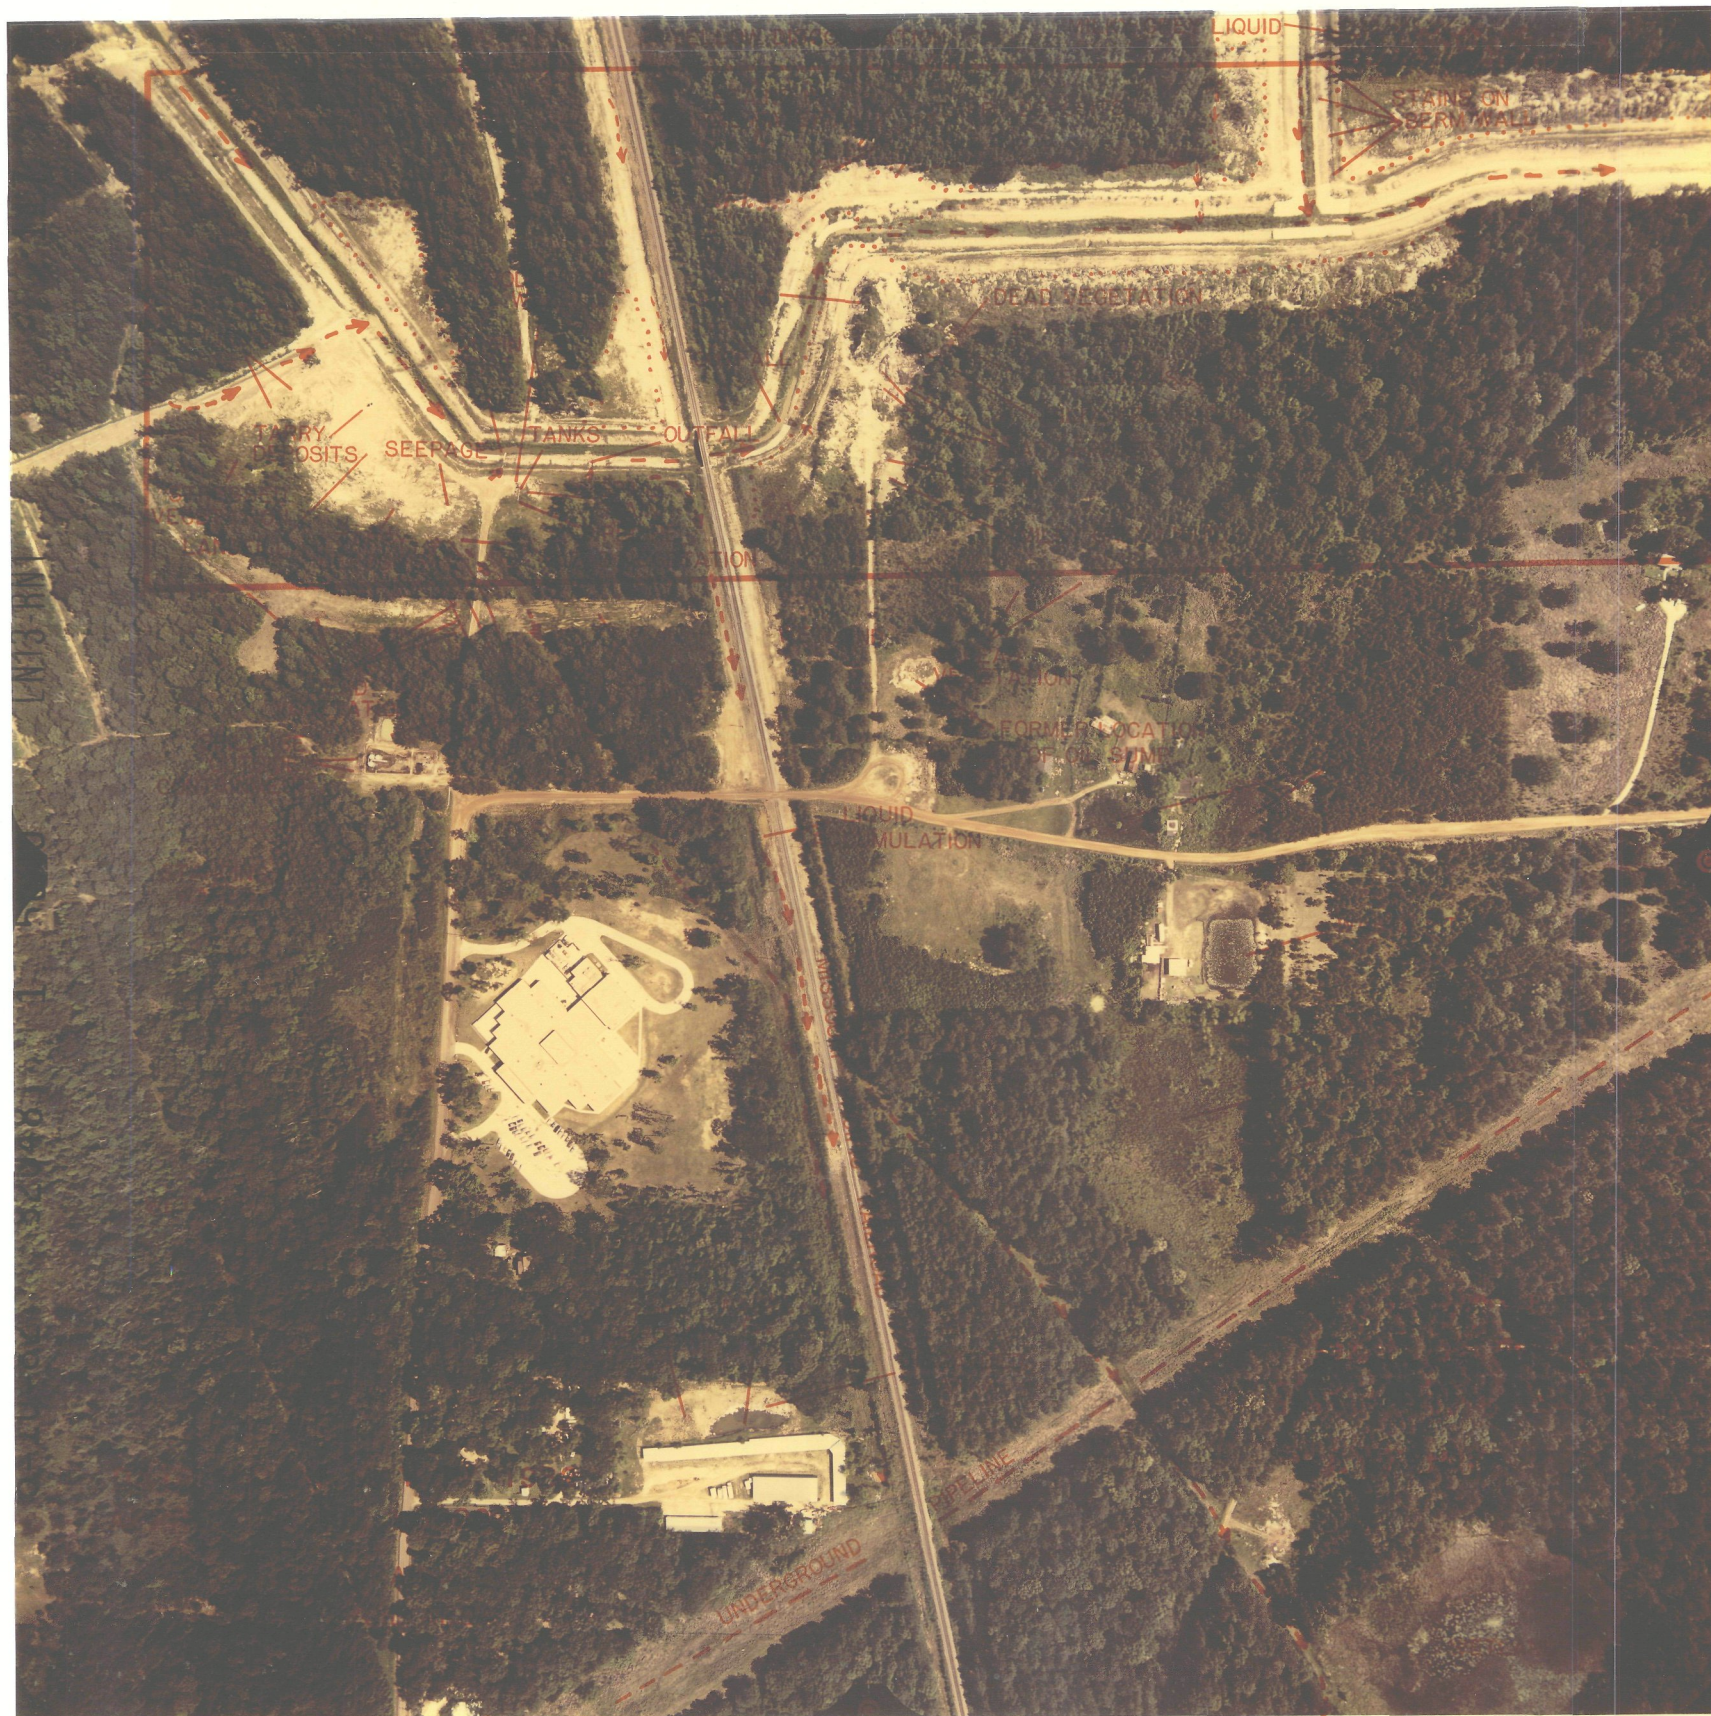
Levee walls enclose a ditch that was visible on the 1968 photograph (Figure 33). A second ditch has been constructed to form a perpendicular confluence with the above-mentioned ditch. Excavated soil has been amassed into spoil areas and a landfill that abut the levee walls. Stains are visible upon a berm wall of the new ditch. Absence of seepage that leads away from an adjacent spoil area makes the origin of the stains uncertain.

Tar deposits and a gray milky substance have been disposed of amid the spoil material. Yellow discolorations and black stains noted within the spoil areas are most likely seepages from the tar deposits. An oil production well, associated tanks, and a pipeline are noted near a spoil area. Spill stains are evident at this location.

Outfalls, drain pipes, and other surface drainages are present within the site. Some of the drainage outlets empty into the drainage ditch whereas others flow towards areas south of the ditch. Dead and stressed vegetation is noted in areas adjacent to the ditch as well as in areas farther south.

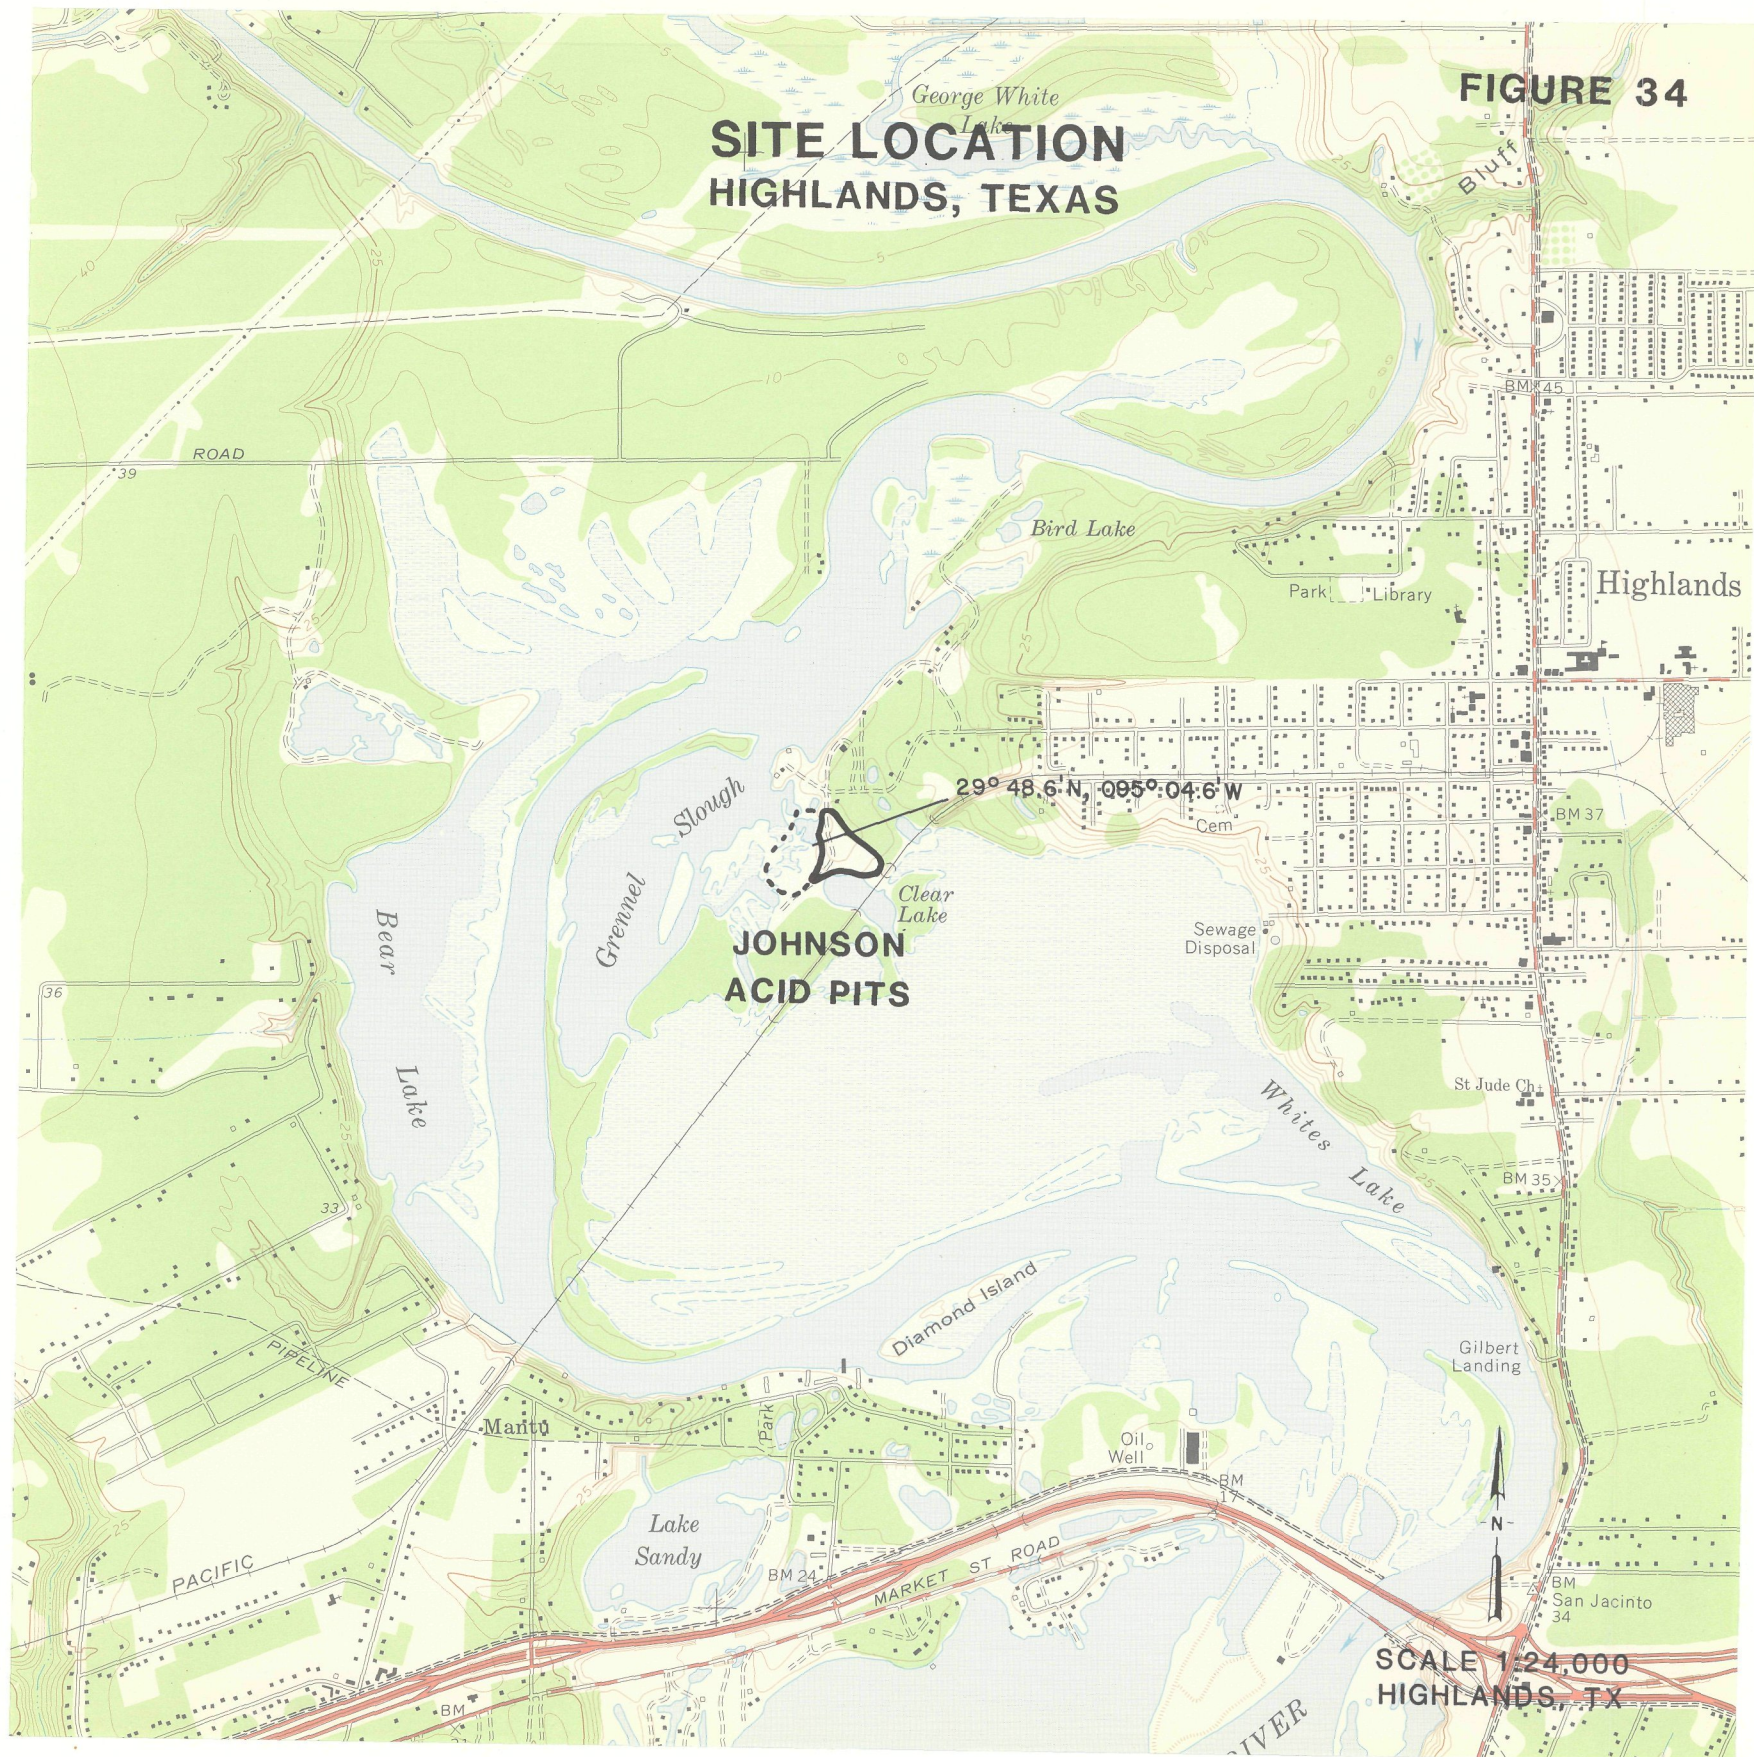
A single disposal pit was dug at some time between January 1939 and April 1944 (Figures 35 and 36). The site was expanded by March 1953 (Figure 37) to include seven waste pits and a landfill disposal area. An unidentified substance was visible within the easternmost pits and in soil depressions. Most of the waste pits had disappeared by March 1957 (Figure 38) but the unidentified substance continued to be dumped within the depressed areas. By October 1964 (Figure 39) all wastes pits were gone. Landfilling activity continued to be visible along the eastern edge of the site. Seepage was noted on a photograph that was collected on October 16, 1966 (Figure 40).

At some time between October 1966 and August 1973 (Figure 41) the western half of the Johnson Acid Pits became totally submerged. It is likely that contaminants which may have been present within this section of the site during this period, were washed into the surrounding waters. An aerial photograph that was collected on May 10, 1982 (Figure 42), revealed that the area that formed the eastern half of the Johnson Acid Pits remained above water. At that time the area was being used for the disposal of solid wastes. Flood waters have inundated a large tract of land east of the Johnson Acid Pits, but flood waters have not reached the remaining portion of this site.

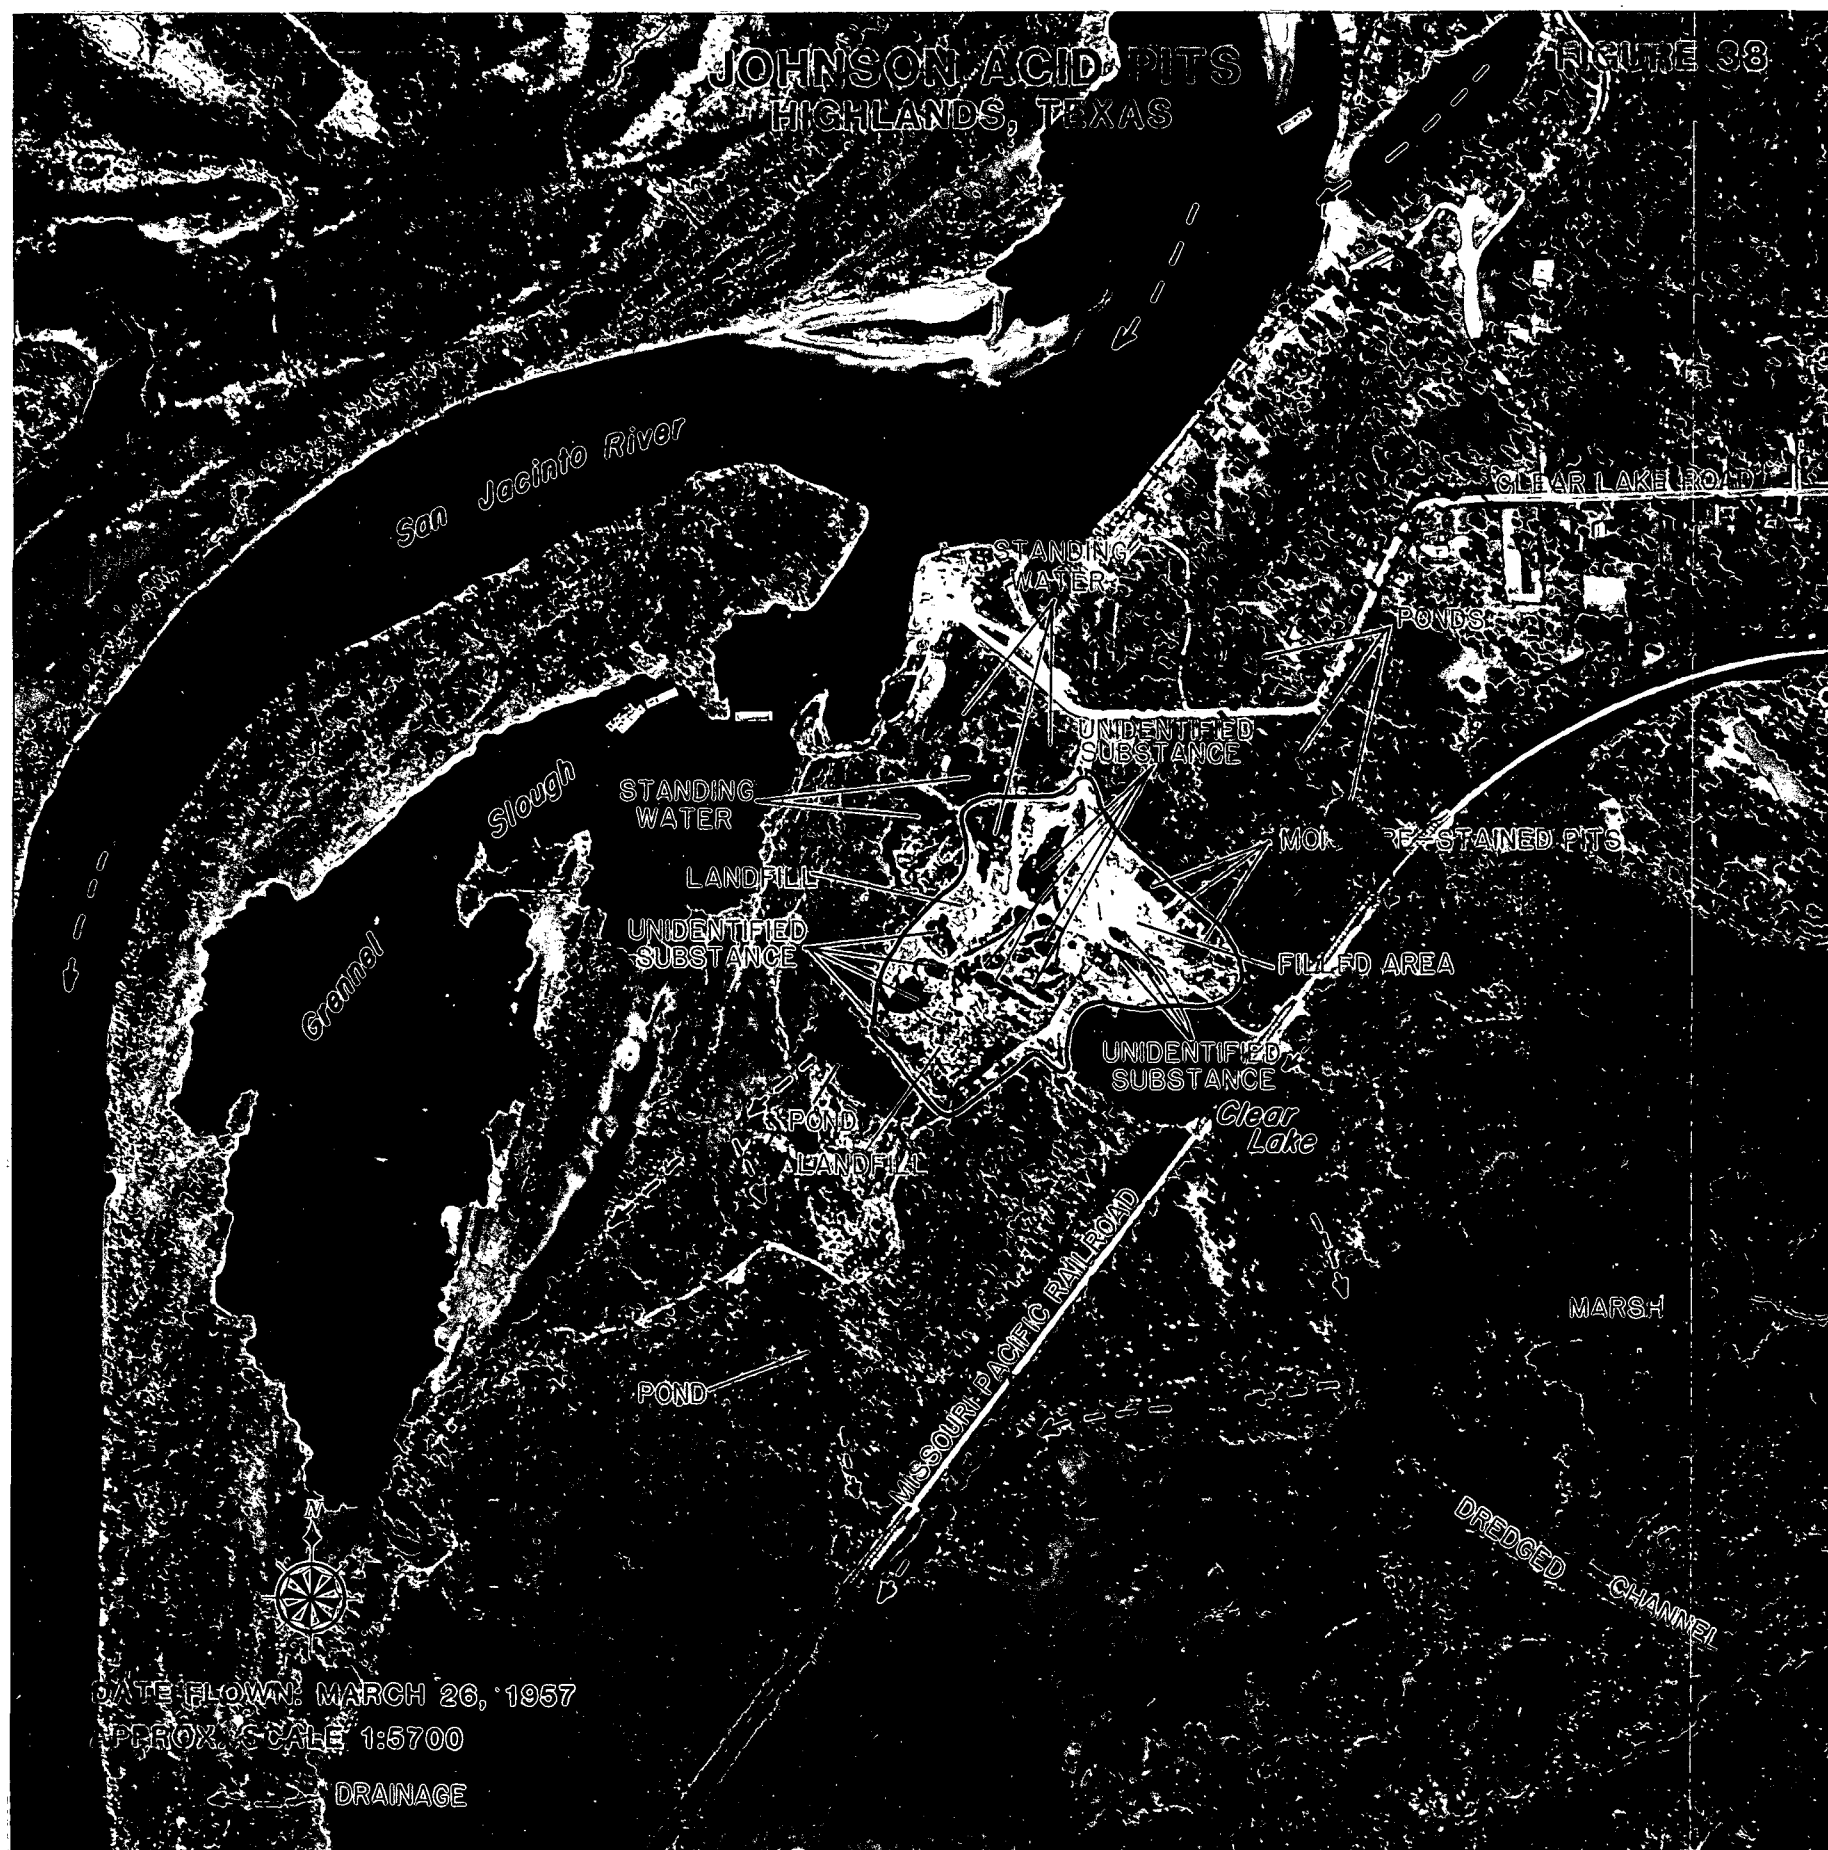
Two of the five liquid-filled disposal pits that were present on the March 1953 photograph are no longer visible (Figure 38). Their former locations have been filled. The three remaining disposal pits have been drained, and moisture stains are in evidence. Two additional disposal pits that were present in the southwest corner of the site have also disappeared. A landfill occupies this portion of the site.

An unidentified substance similar in tone to that visible on the 1953 photograph (Figure 37) has ponded within site depressions. A pond that is located southwest of the disposal area appears to contain some of the unidentified substance. No traces of the foreign substance are visible within Clear Lake or the San Jacinto River.

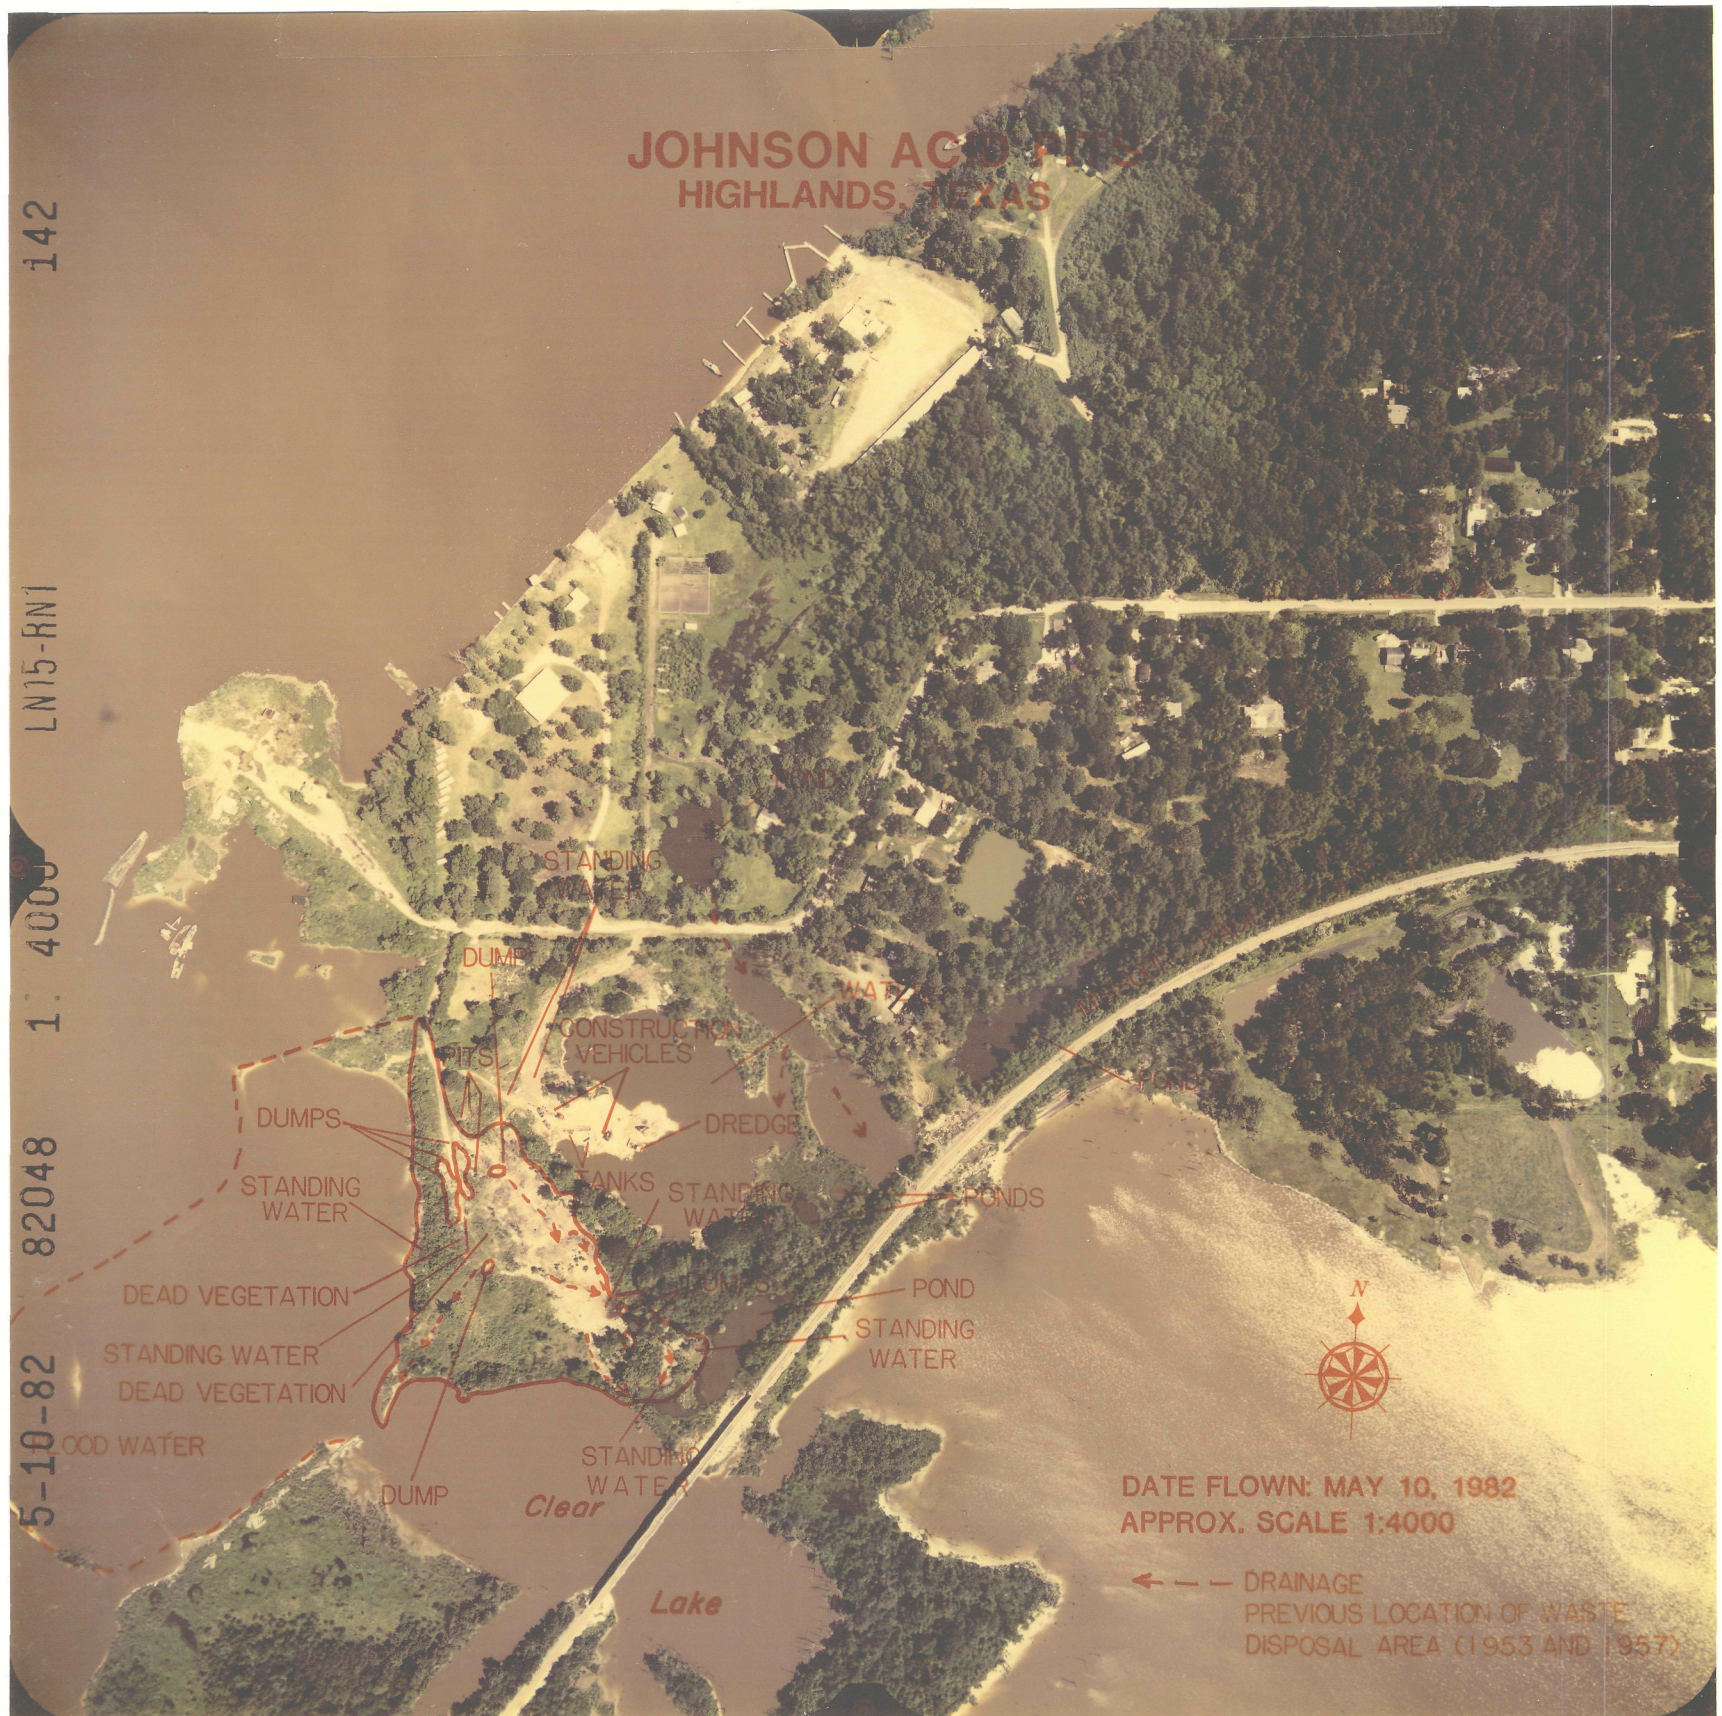
Solid wastes and old tree limbs have been dumped within the disposal site (Figure 42). Three shallow pits are also present. Rainwater has collected in several site depressions, creating small ponds. Much of this standing water is highly discolored. There is no indication that the liquid has entered larger bodies of water that abut the site. Some dead vegetation is visible within the site.

An area east of the disposal site is inundated with water. This water has not reached the level of the disposal site. A dredge and several construction vehicles are operating within the flooded area.
